BLACK & WHITE FIRE SAFETY LTD

FIRE RISK ASSESSMENT

3 Arnhem Place, New Atlas Wharf,
London. E14 3SS

23rd August 2018

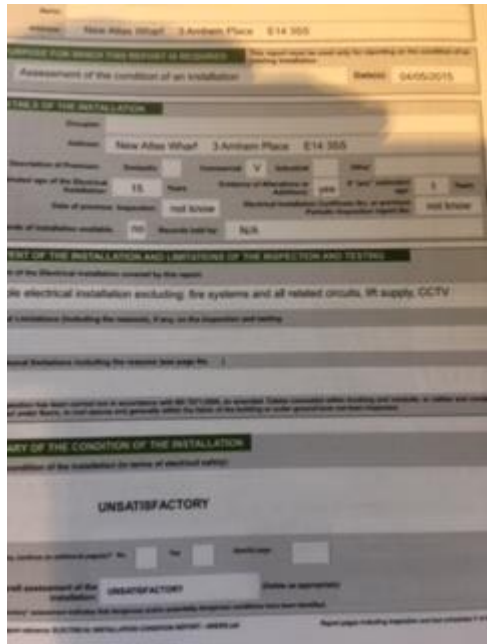
7.3 Comments and hazards observed:		
<p>¹From the paperwork that we were shown the last Fixed installation test was completed on 04/05/15 and the result was deemed Unsatisfactory.</p> <p>²According to the labels on the portable appliances the last Portable appliance testing was completed on 04/11/16.</p> <p>We understand that Estate Management hold all of the up to date paperwork for servicing/maintenance but they were not available at the time of our inspection.</p> <p>³It should be ensured that any personal electrical equipment is PAT tested before use.</p> <p>See Part 6 – Significant Findings</p>

Record showing that the buildings electrical installation is unsatisfactory	Combustible items within the car park	Vent within Core one

FSO Article 17 - Maintenance				
<p>20. The buildings electrical installation should be inspected at least every 5 years in the case of the common parts by a competent electrical engineer. The inspection and test, and any necessary remedial work, should be undertaken in accordance with the current Institution of Engineering and Technology (IET) Wiring Regulations (BS7671) and the recommendations in IET 'Guidance Note 3'.</p> <p>An inspection certificate for each inspection should be held on file for inspection by the fire authority.</p>		On-going	1	
<p>21. PAT testing should be carried out in accordance with the Institution of Engineering and Technology (The IET) published "Code of Practice for In-service Inspection and Testing of Electrical Equipment" (ISBN: 978-1849196260).</p>		On-going	1	
<p>22. Arrangements should be made to include staff electrical appliances in the PAT testing policy and Staff should be reminded that any electrical equipment including mobile phone chargers brought into or used in the workplace should be authorised and PAT tested before use</p>		On-going	1

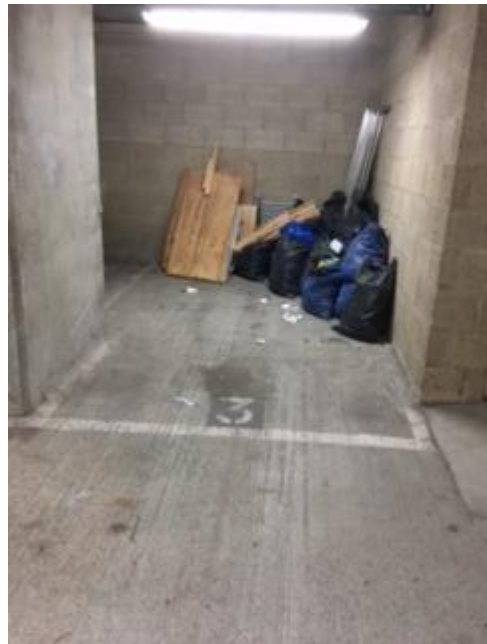
13.3 Comments and hazards observed: The combustible materials within parking bay 3 should be removed and this practice should cease. Riser cupboards should not be used for storage. Storage in the Core 2 electrical intake room should be limited to a minimum, and be stored at least 1m from any electrical equipment. It should be ensured that where bike storage has been permitted in the electrical intake rooms. No bikes should be stored within 1m of any electrical installation. If this cannot be maintained the use for storage in these areas should cease. The car parking bay between Cores 6 & 7 has been blocked off and is currently being used as a storage area whilst the works are continuing on the podium level. This storage should be kept at least two metres away from the separating grill of the adjoining car park. There should be regular checks to ensure that there is no unnecessary accumulation of combustible material near ignition sources or along escape routes. All exit routes should be maintained clear with a minimum of 1 metre clear gangway through to exit doors See Part 6 – Significant Findings

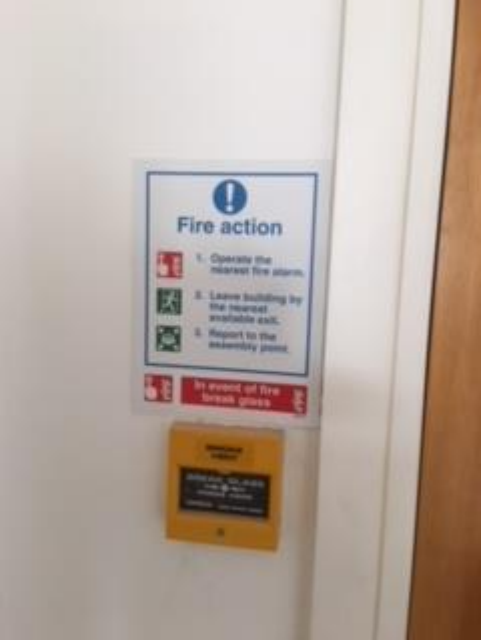
Misleading signage to be removed.	Doors being wedged open	Combustible items within the electrical intake room

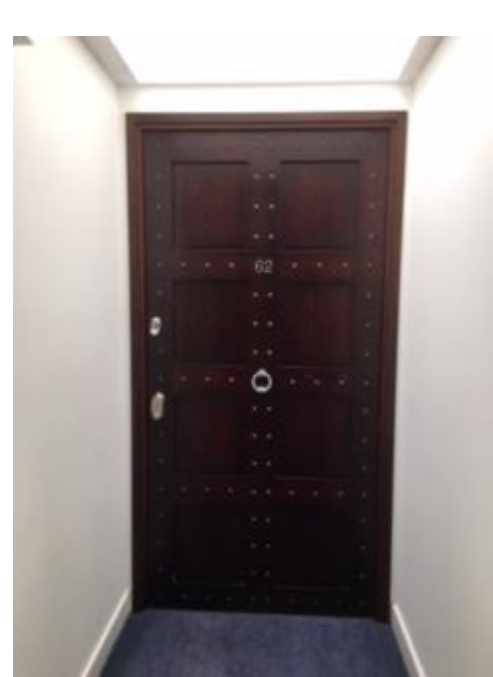
Confirmation of fire door required

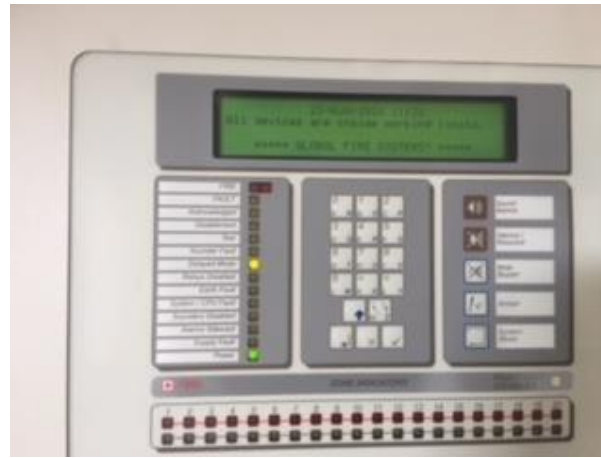
Fire panel in delayed mode

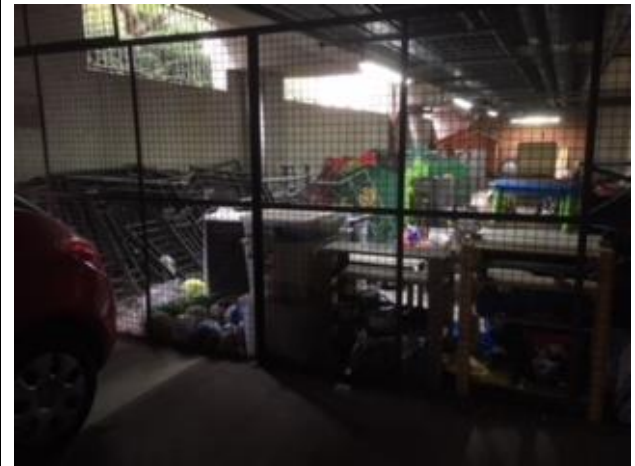
Storage within car parking bays to be at least 2 meters away from fencing

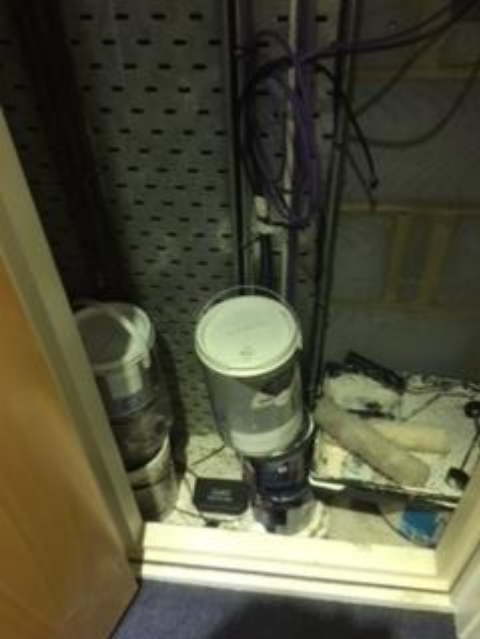
<p>Paints within the riser cupboard</p>	<p>Hole within the ceiling of the chemical store</p>
